# Coastal Unit K2 : Te Awanga

## Pathway for coastal hazard management for Te Awanga

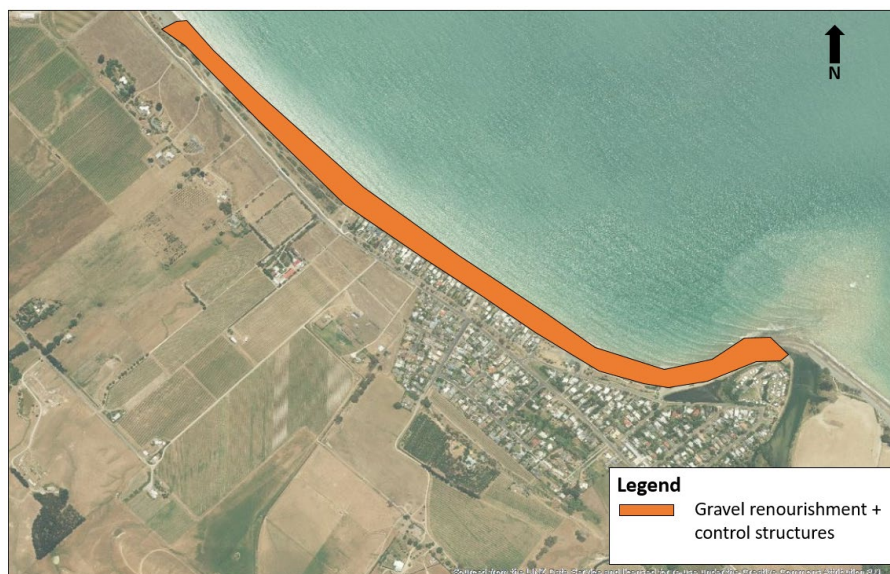
Indicative gravel renourishment and groyne structure location at Te Awanga.

Renourishment and groynes is the preferred pathway for managing coastal hazards at Te Awanga.

TE AWANGA – PREFERRED PATHWAY				
Short term (0 – 20 years)	→	Medium term (20 – 50 years)	→	Long term (50 – 100 years)
Renourishment + Groynes	→	Renourishment + Groynes	→	Renourishment + Groynes
